News on Adapter Board impedance matching and HDI testing

Suvadeep Bose

University of Nebraska Lincoln

January 17 , 2014

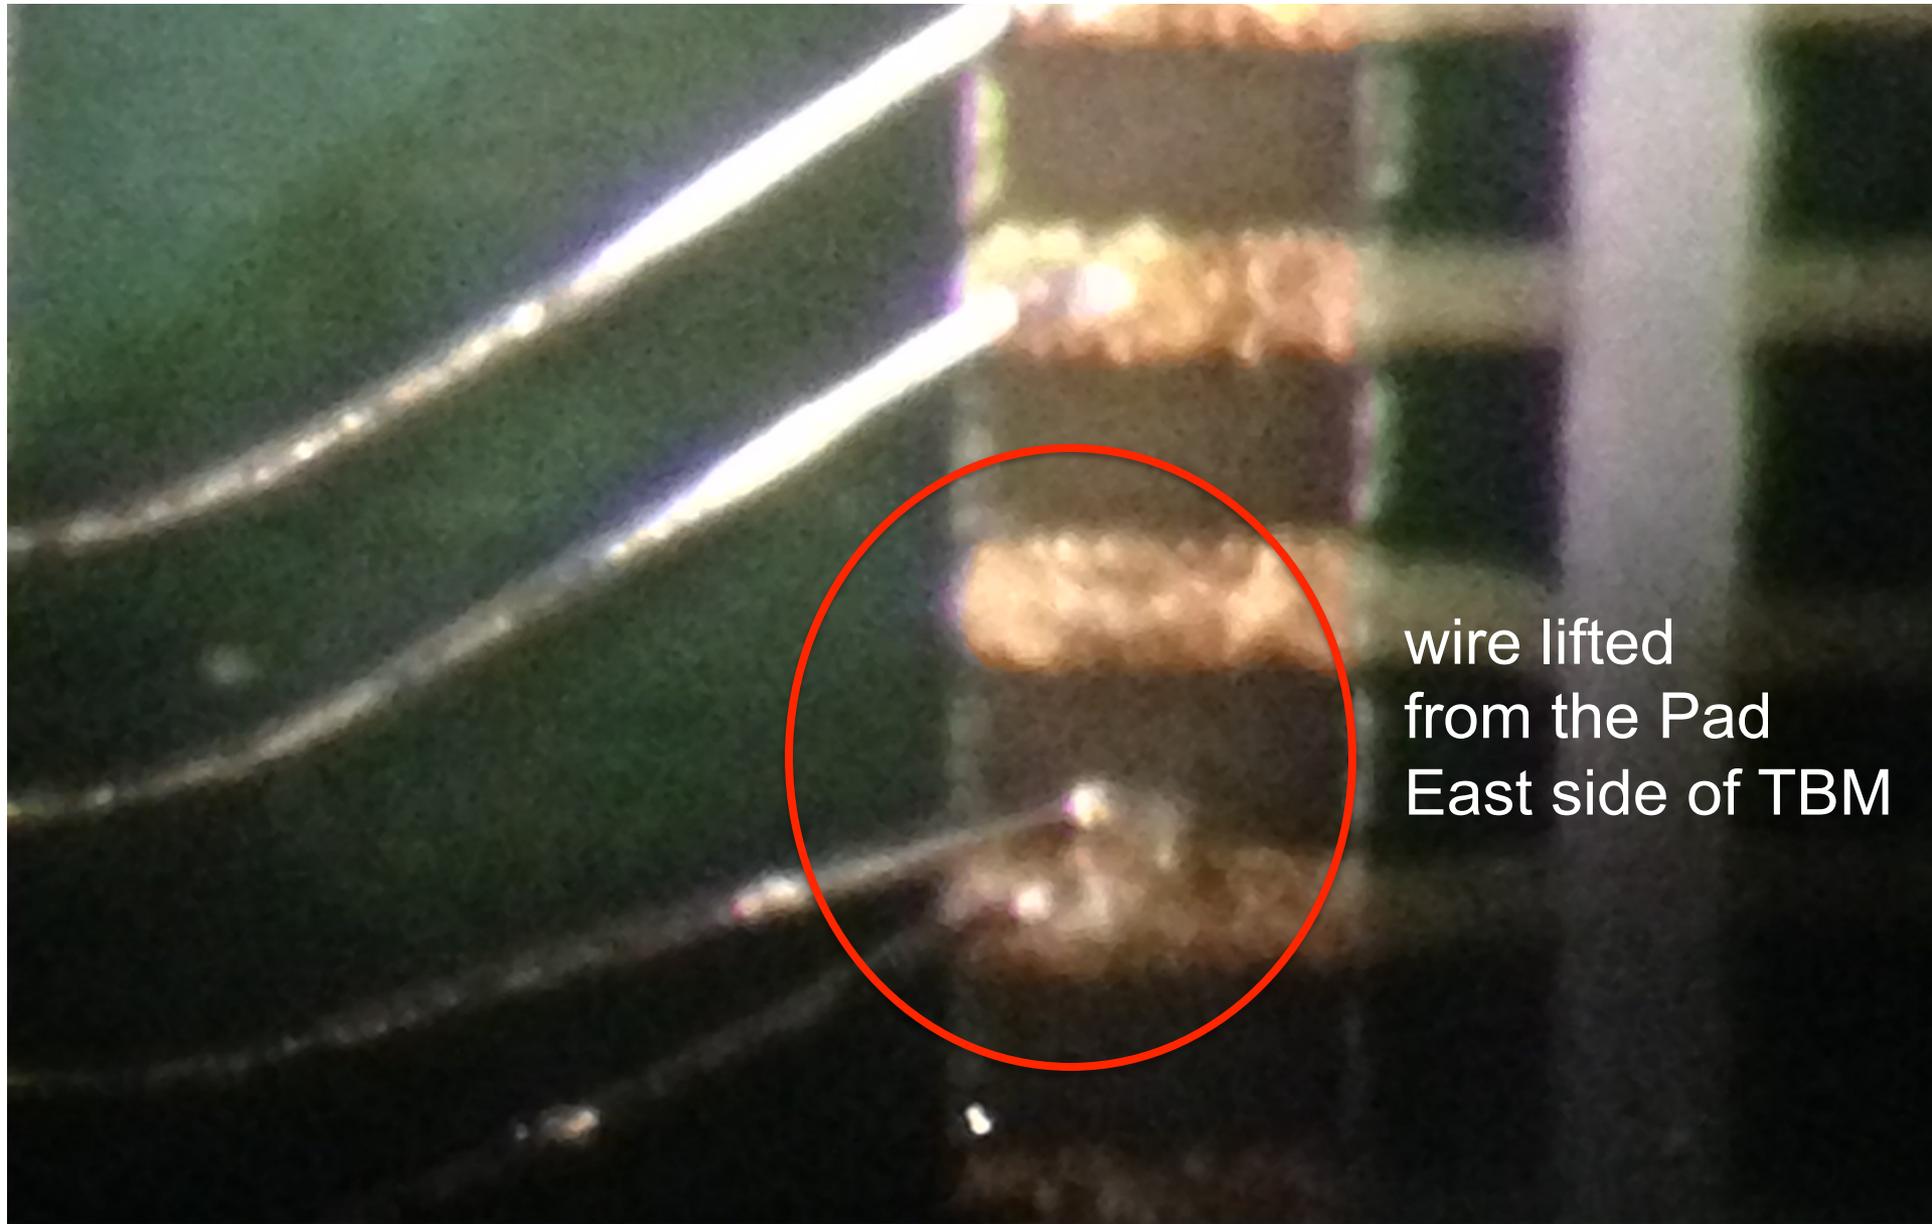
- When tested on 01/17/13 – two of them showed bad signal – on investigation we found that wire bonds were lifted/displaced in two of them – see following slides:

wire lifted
from the Pad
East side of TBM

- Immediate Remedy: As these are not encapsulated we can get them wire bonded again

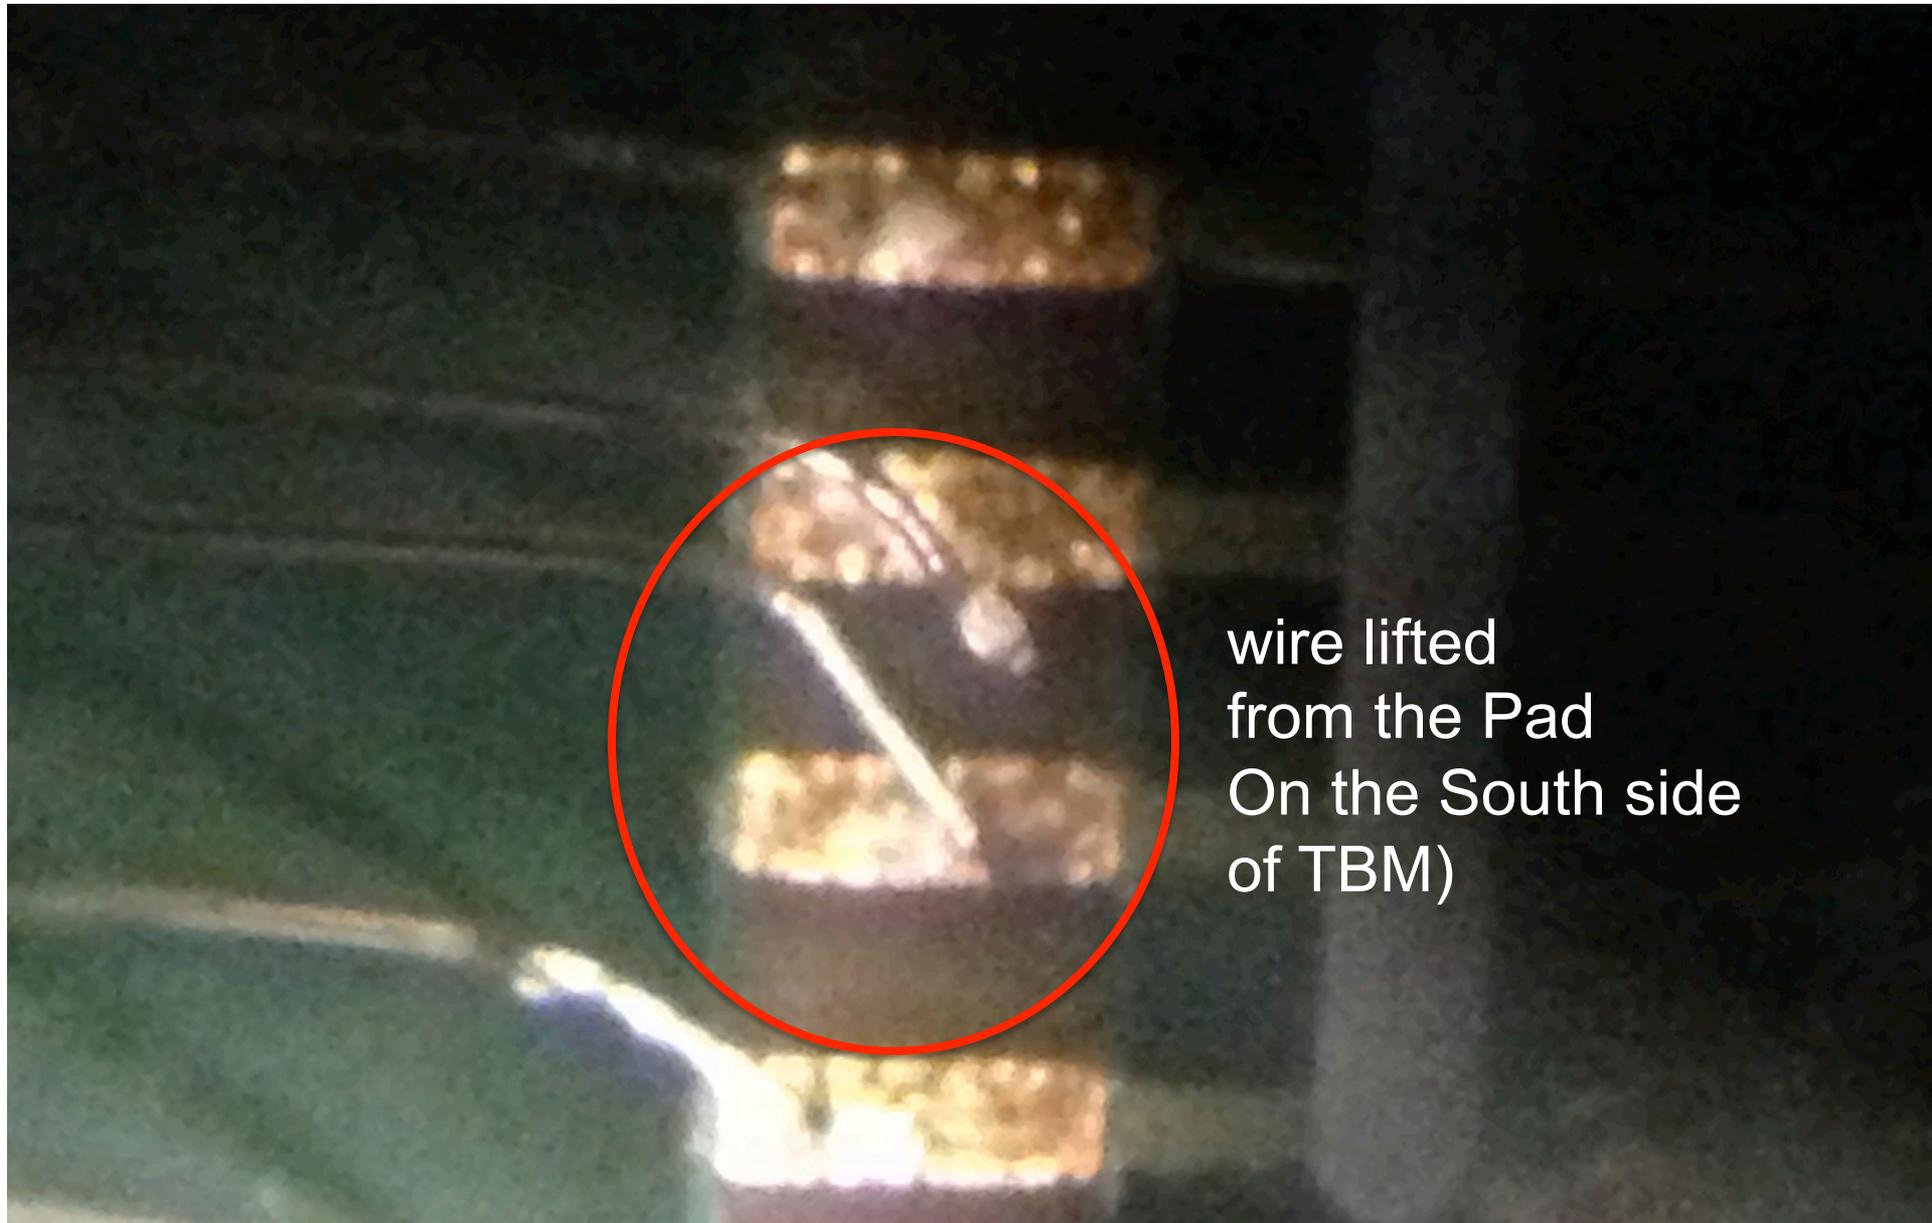
wire lifted
from the Pad
On the South side
of TBM)

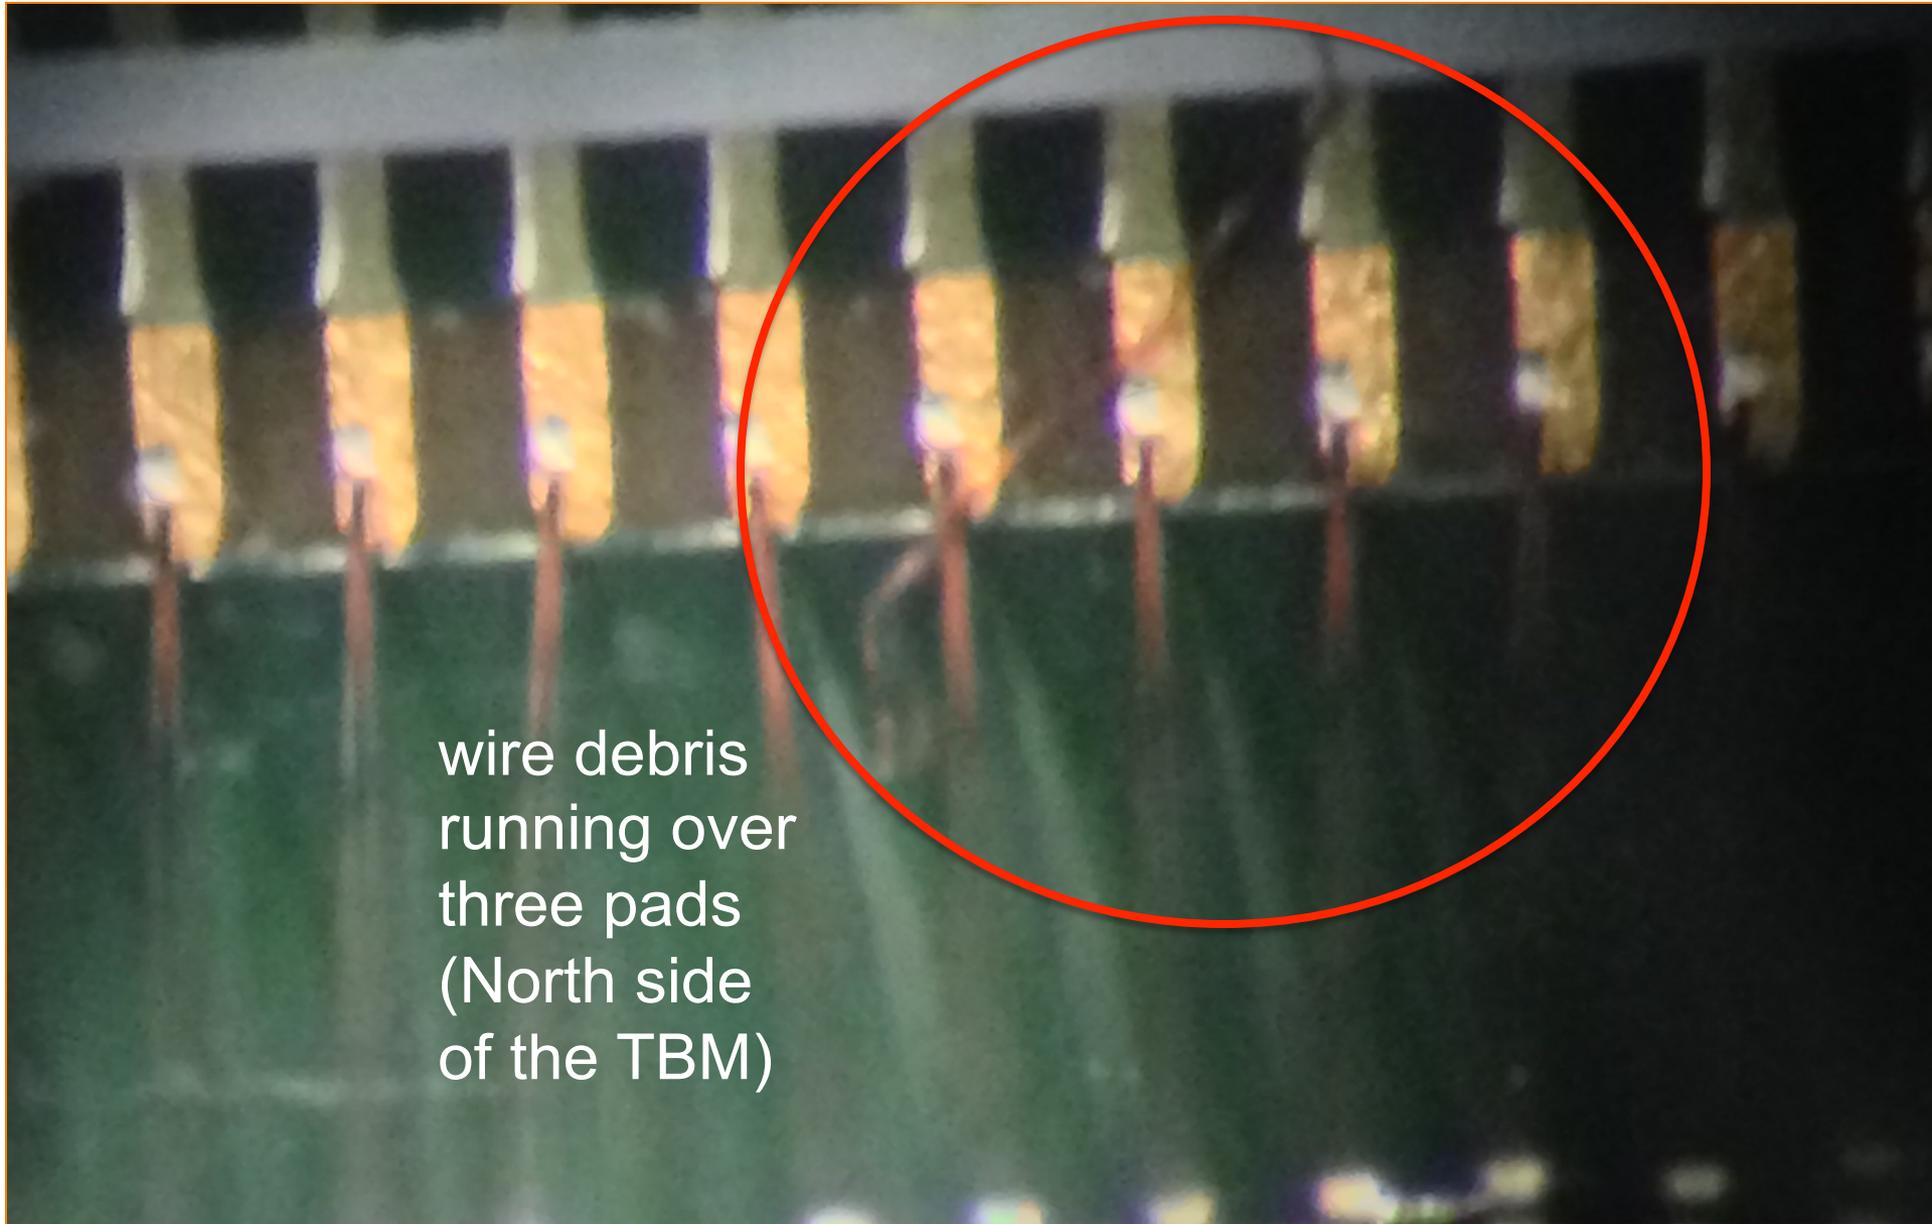
wire debris
running over
three pads
(North side
of the TBM)

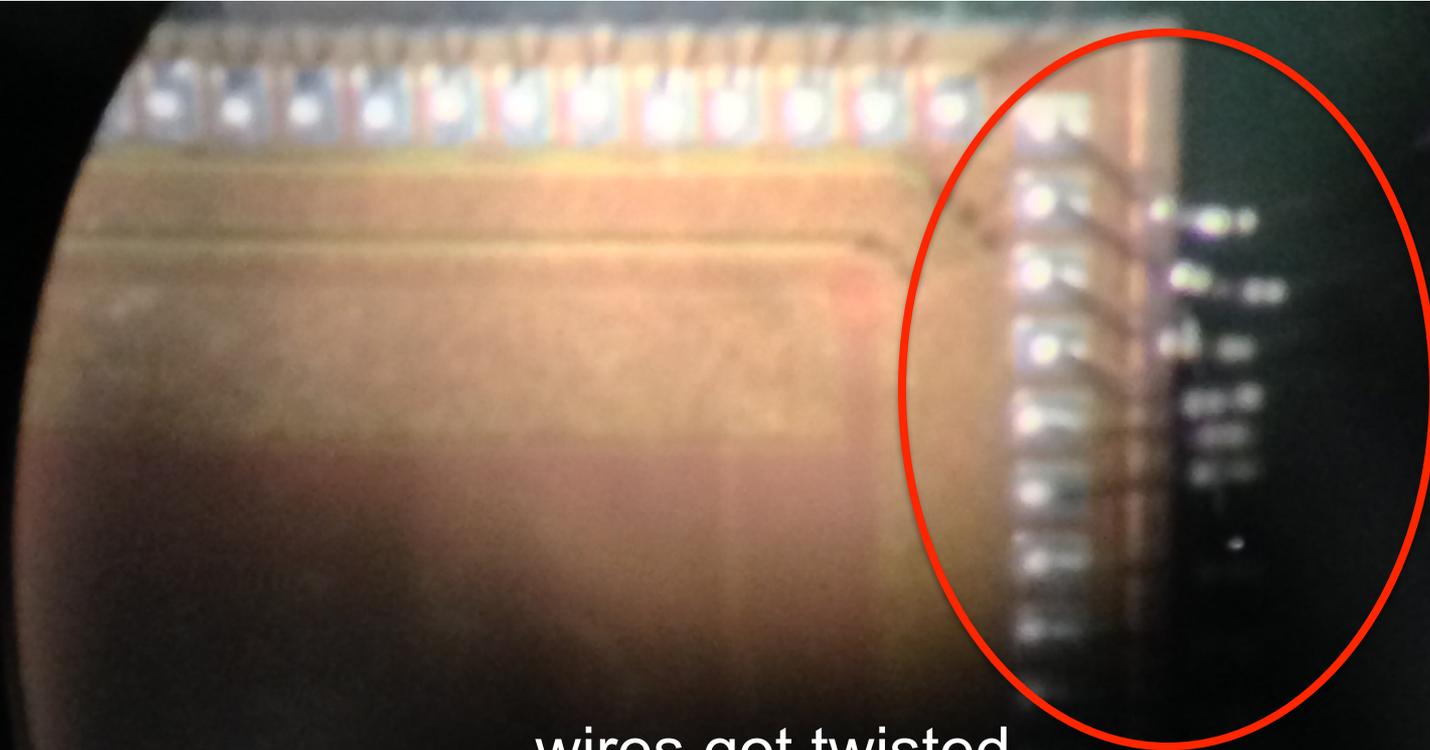
wires got twisted
(looks like the soldering
wire or something just
pushed them together)
NE side of TBM

- ❖ Possible sources for the damage of wire bonds:
 - These 4 HDI's were not encapsulated
 - Handling of the HDI – transport to a different place to solder the 2.5 V
 - While soldering the 2.5 V wire
 - Most importantly, while putting the flexi cable in the SMK connector on HDI during testing
 - Moreover, while testing the HDI's are placed on the Kapton foil for electrical isolation – to do this we take out the HDI from the ESD safe boxes and put them on the foil

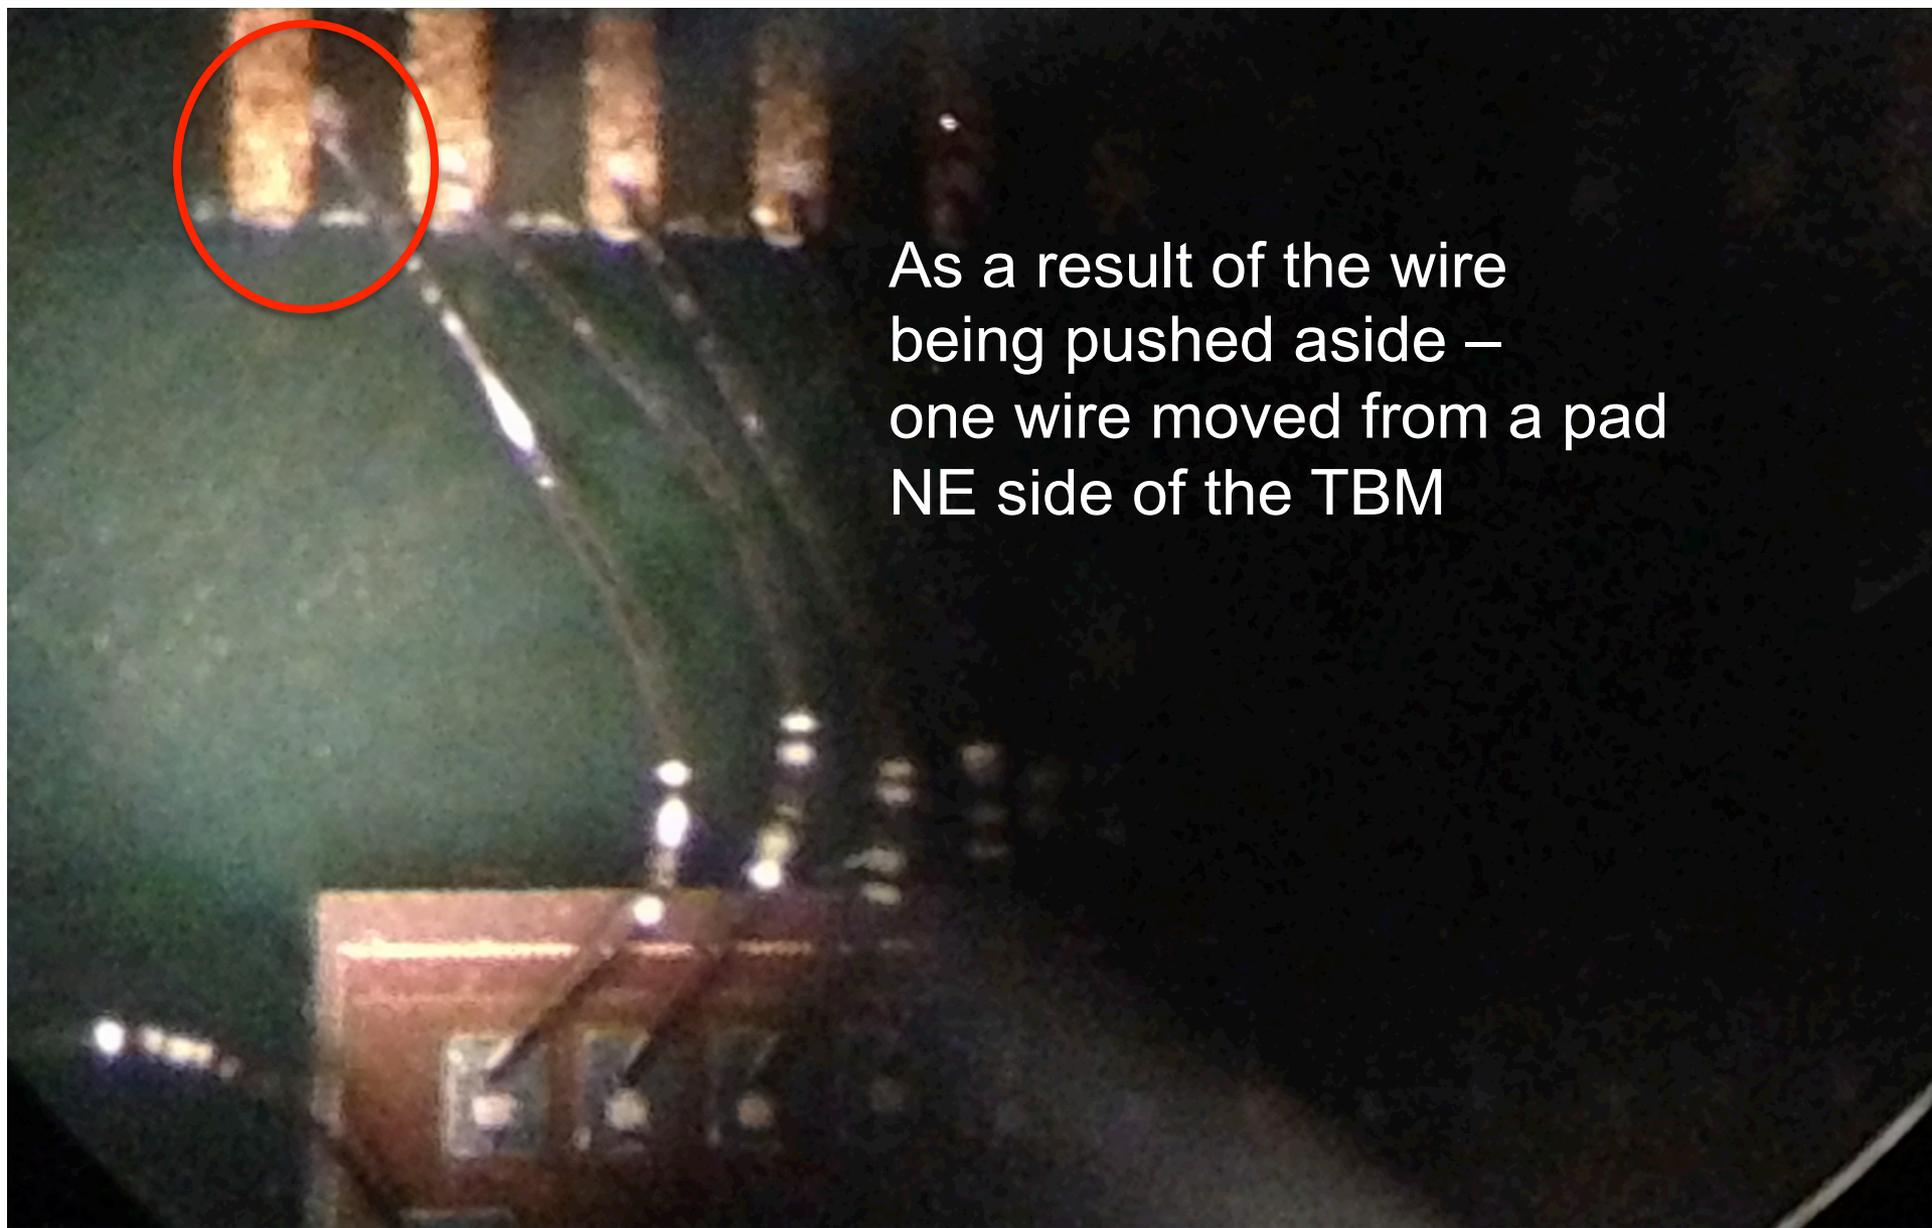
As a result of the wire being pushed aside – one wire moved from a pad NE side of the TBM

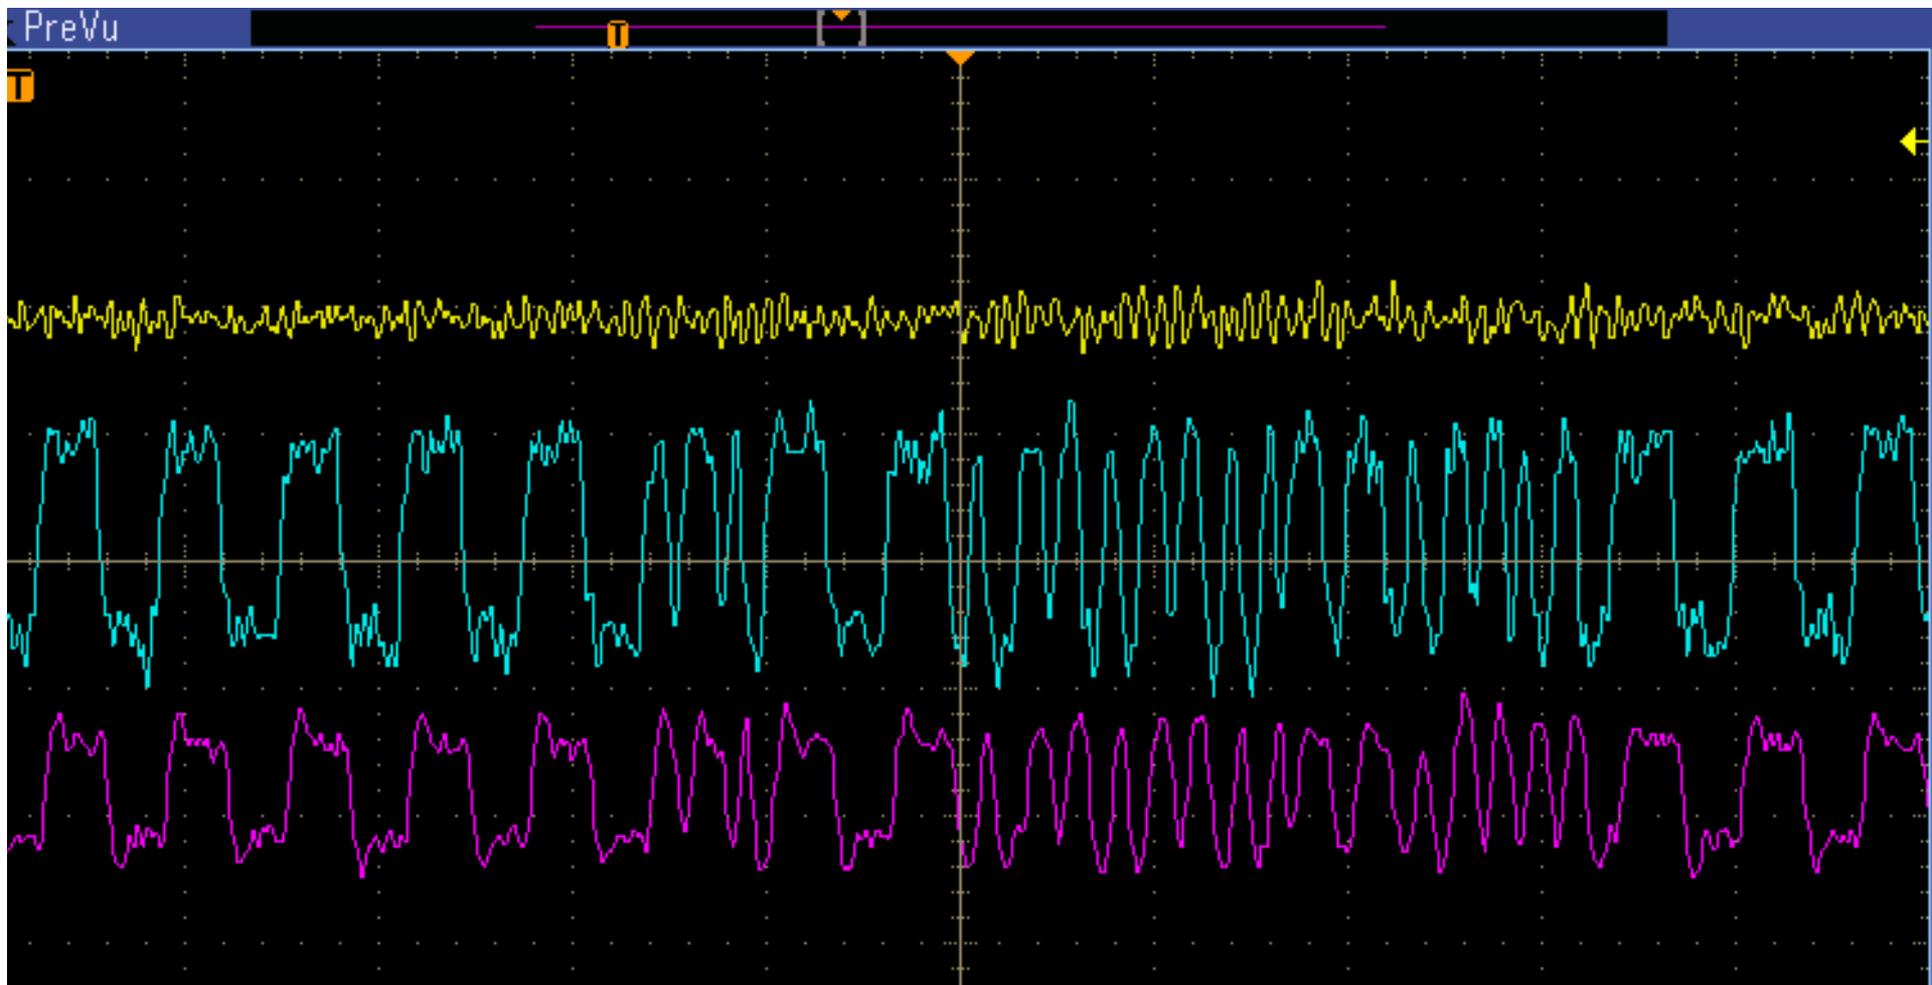
TBM A looks Good
TBM B shows the header
but the trailer is confused
– to be understood

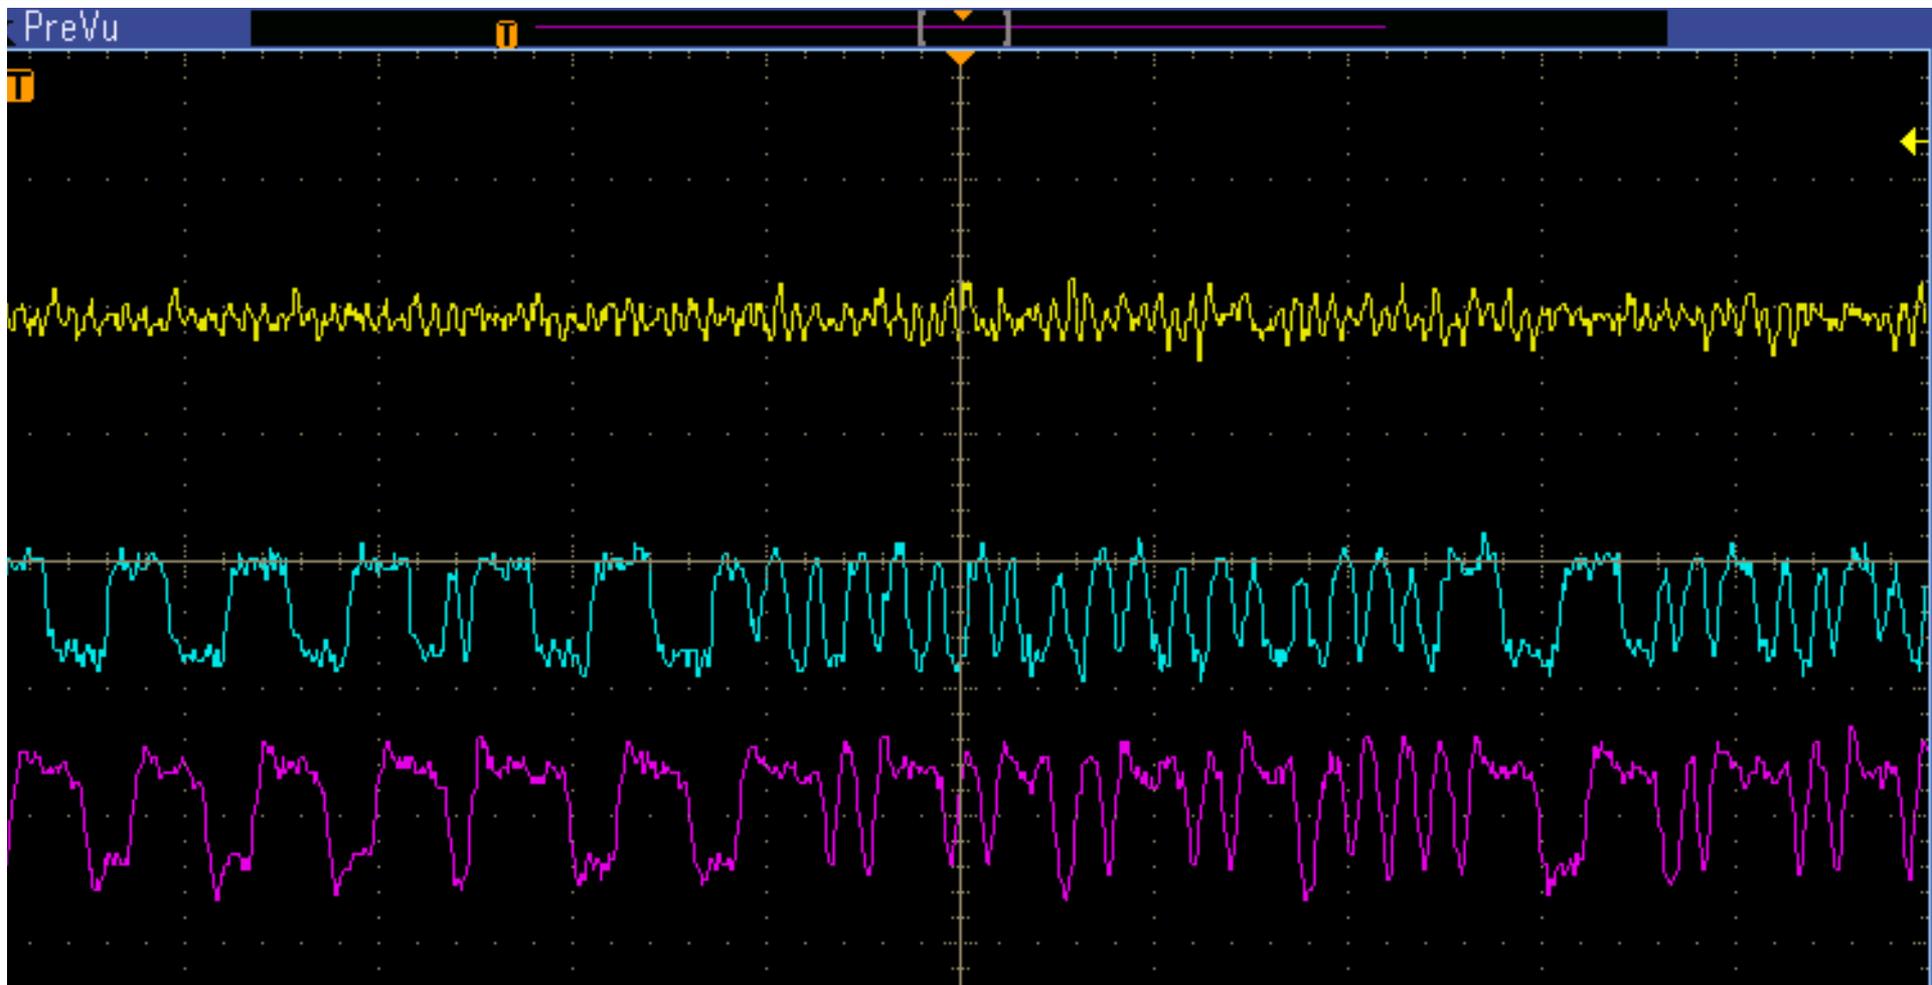
HDI#23

TBM A, B both cores
show the header
but the trailer is confused –
to be understood
