News on Adapter Board impedance matching and HDI testing

Suvadeep Bose

University of Nebraska Lincoln

January 17 , 2014

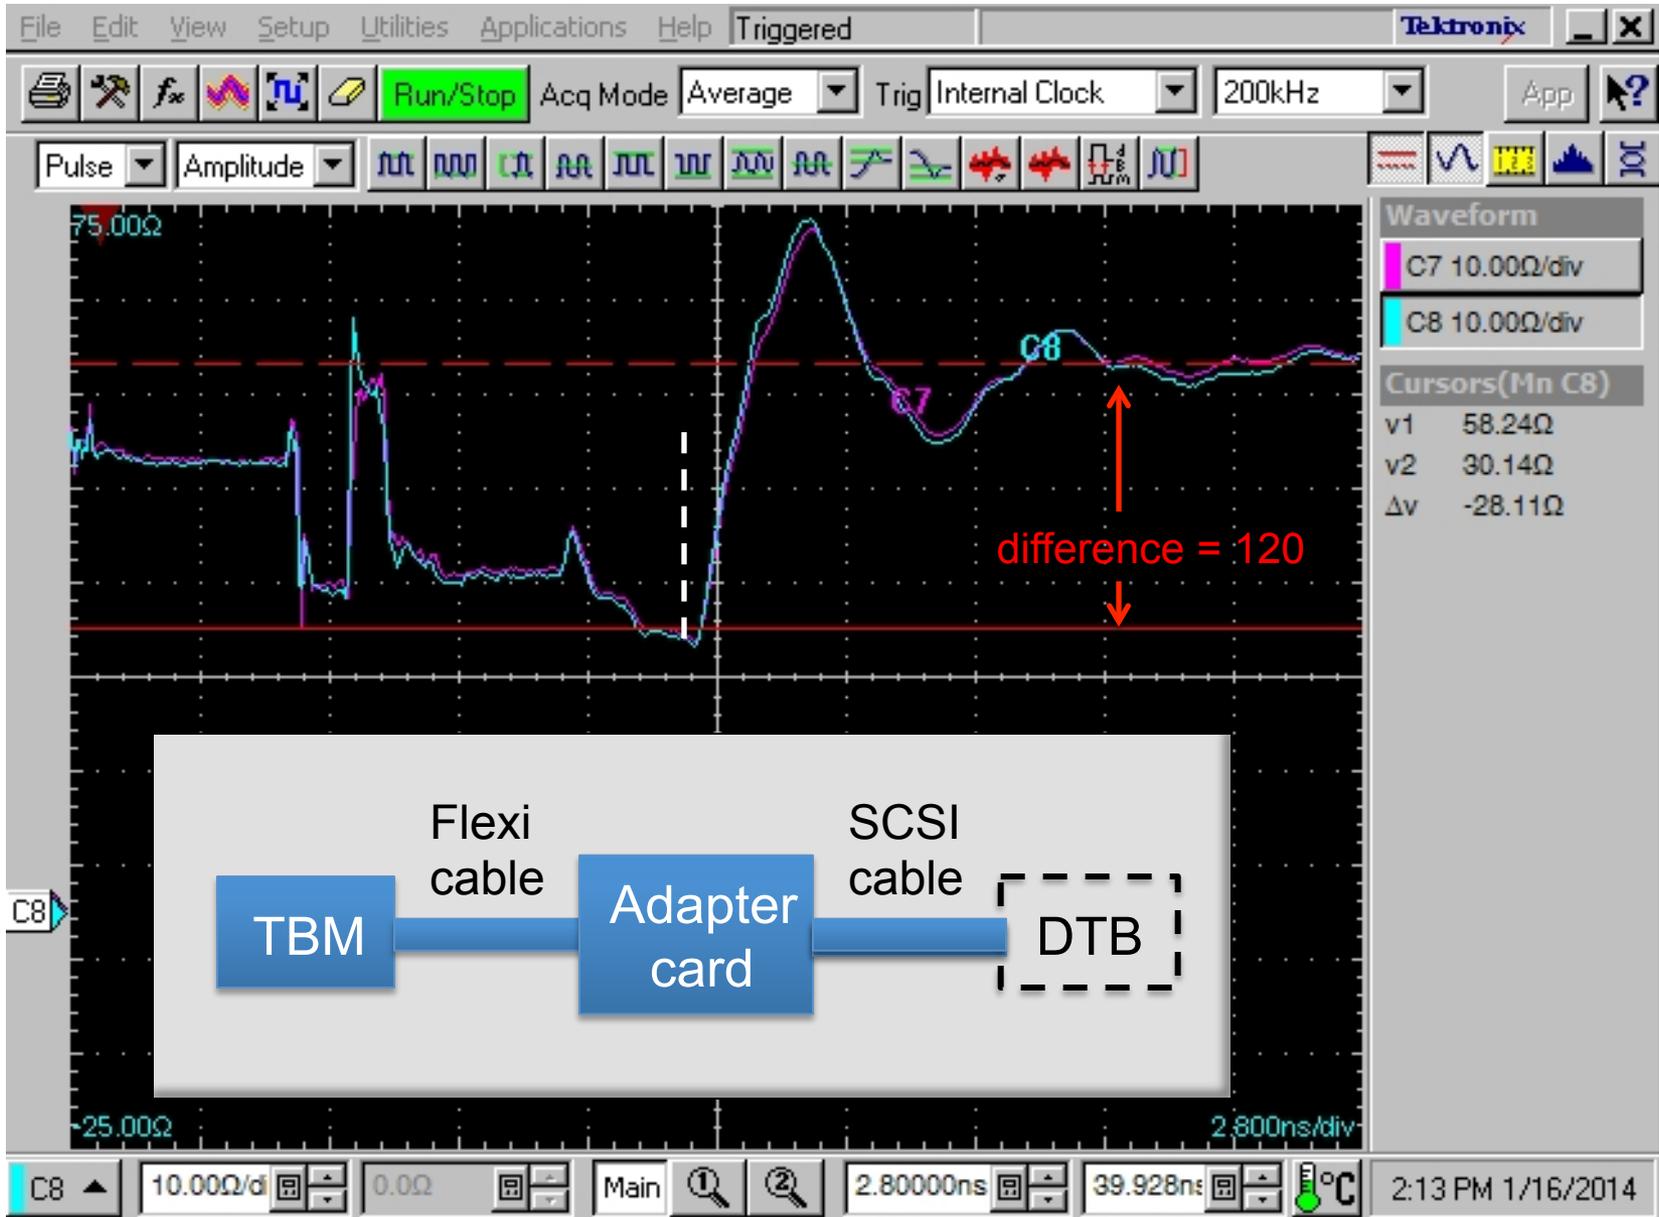
DTB unconnected w/ SDATA1 $R_{total} = 120 \Omega$

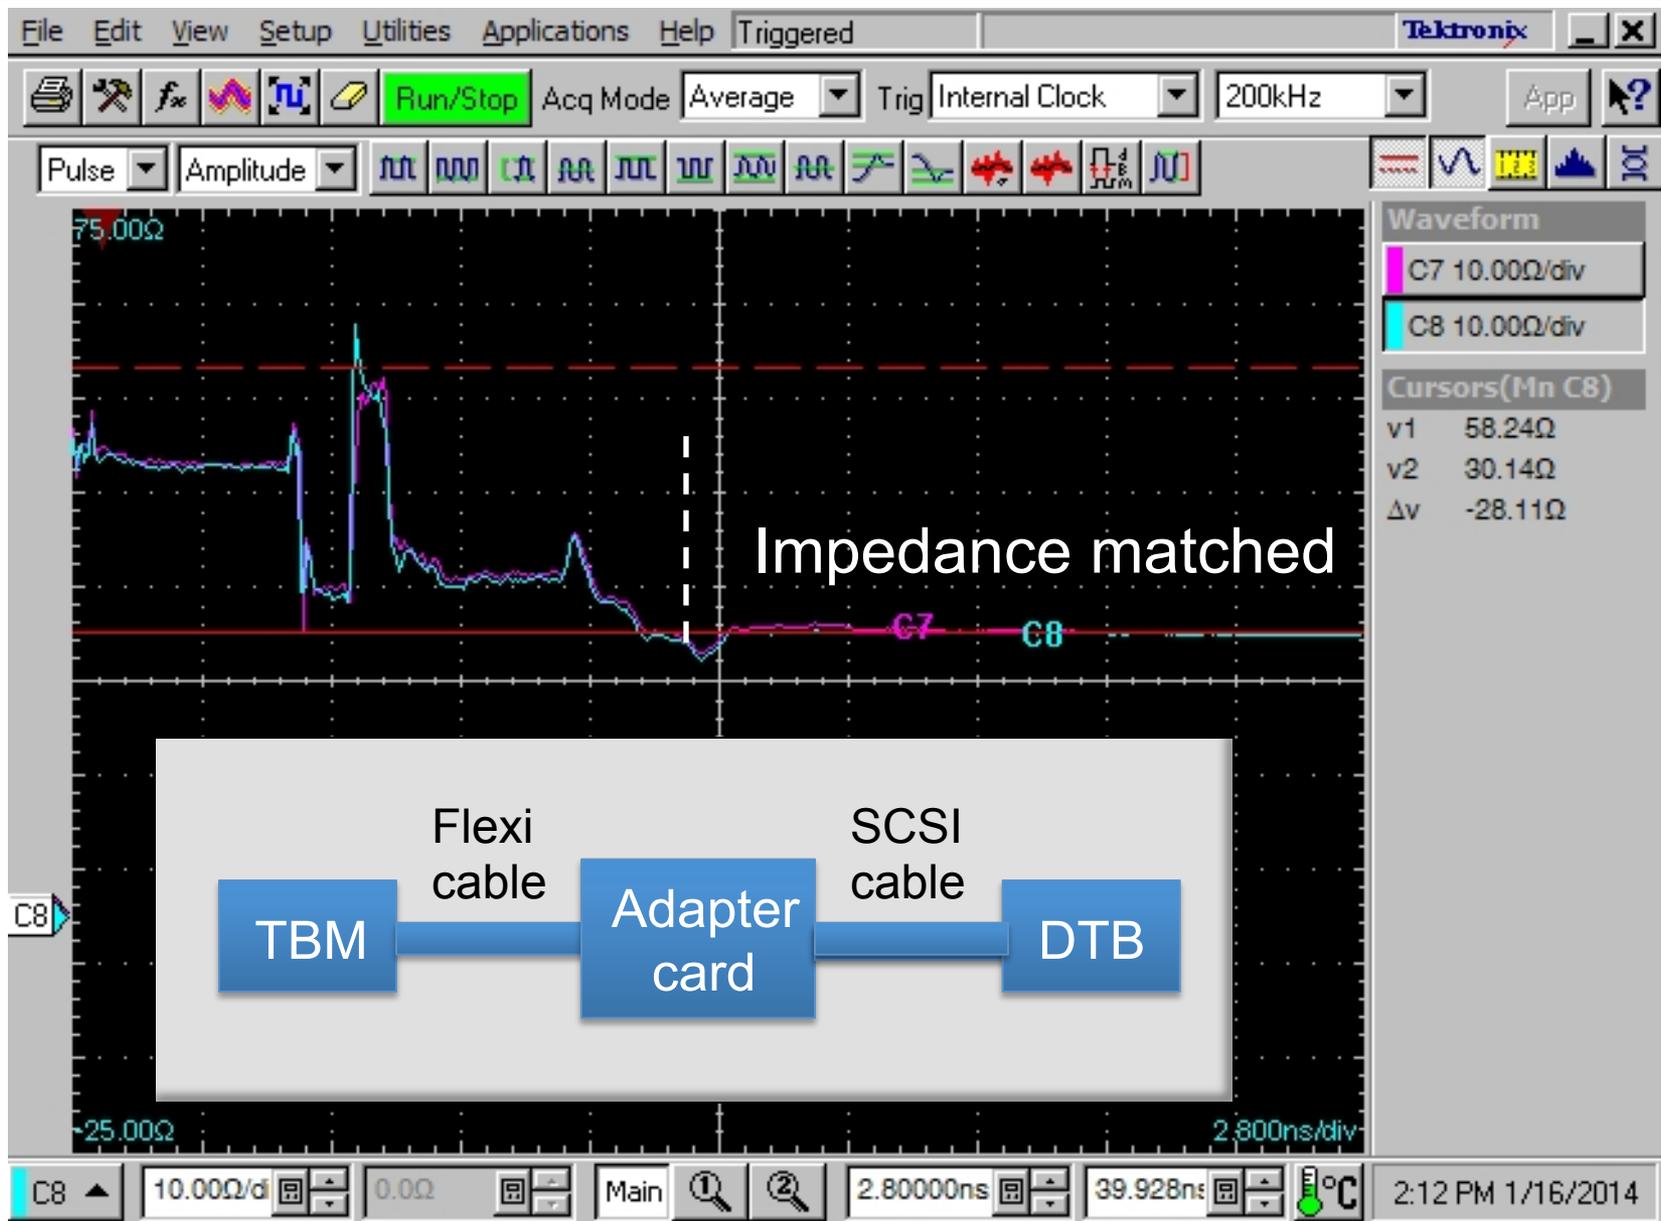
Full chain w/ SDATA1 $R_{total}=120\ \Omega$

- Making changes to the resistors for SDATA1 in the Adapter card showed good result.
- The signal is enhanced and now the analog and digital signal looks similar.
- The decoding is also working fine for both the cores.

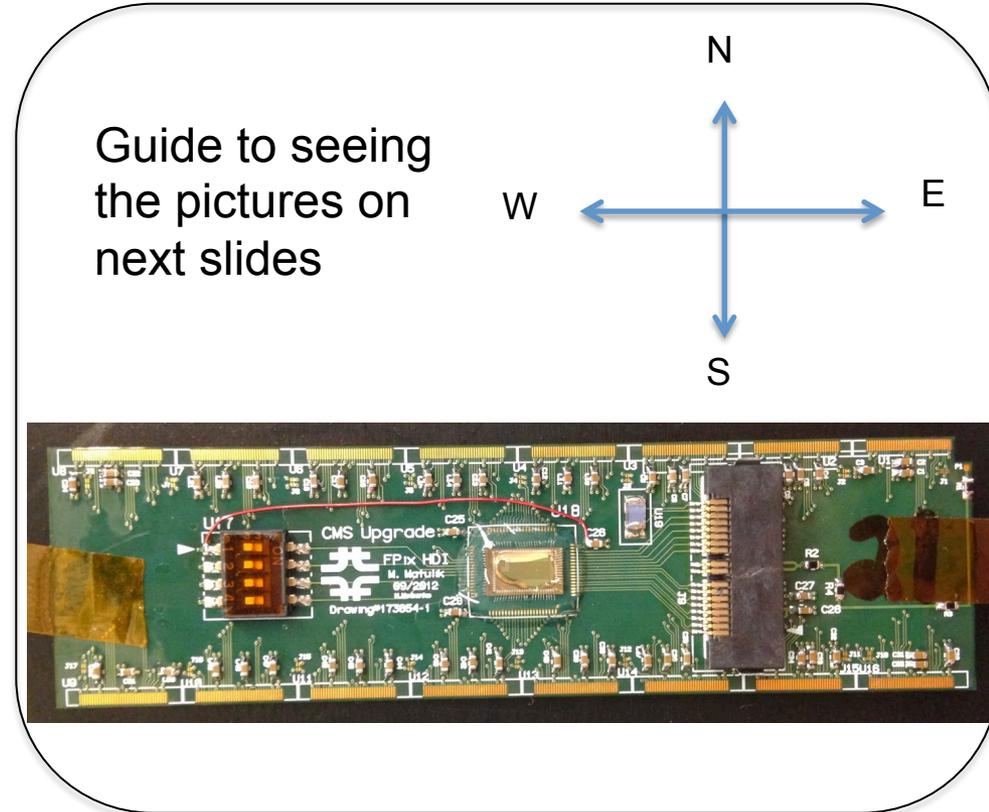
- When tested on 01/17/13 – two of them showed bad signal – on investigation we found that wire bonds were lifted/displaced in two of them – see following slides:

- ❖ Possible sources for the damage of wire bonds:
 - These 4 HDI's were not encapsulated
 - Handling of the HDI – transport to a different place to solder the 2.5 V
 - While soldering the 2.5 V wire
 - Most importantly, while putting the flexi cable in the SMK connector on HDI during testing
 - Moreover, while testing the HDI's are placed on the Kapton foil for electrical isolation – to do this we take out the HDI from the ESD safe boxes and put them on the foil
